## Case Study: 1906 Clapboard House

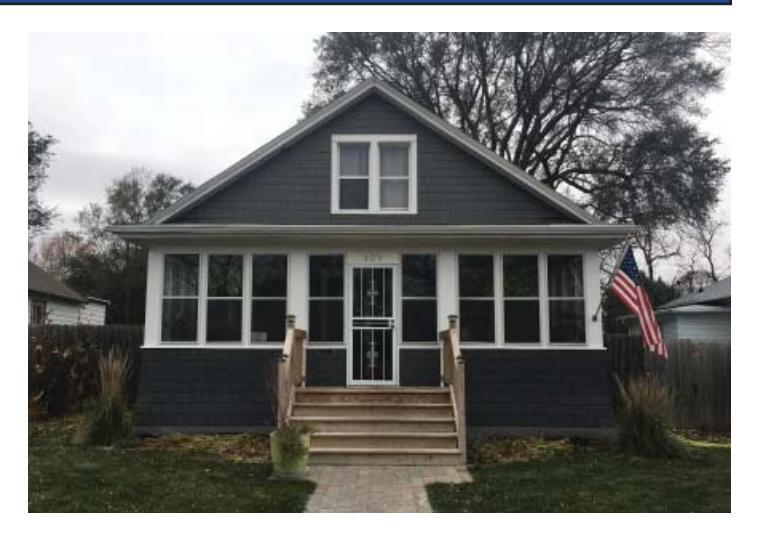
The other big issue was the lead paint on the exterior. The homeowner decided to bypass the costly siding tear off and abatement process. In less time than it would have taken to tear off and clean up the old clapboard siding, InSoFast was installed over top of the existing exterior.

There was no disruption to the exterior siding, window trim, or corners. Nothing was removed or cut. Tearing off the wood siding would have removed over 10% of the existing wall's R-value.

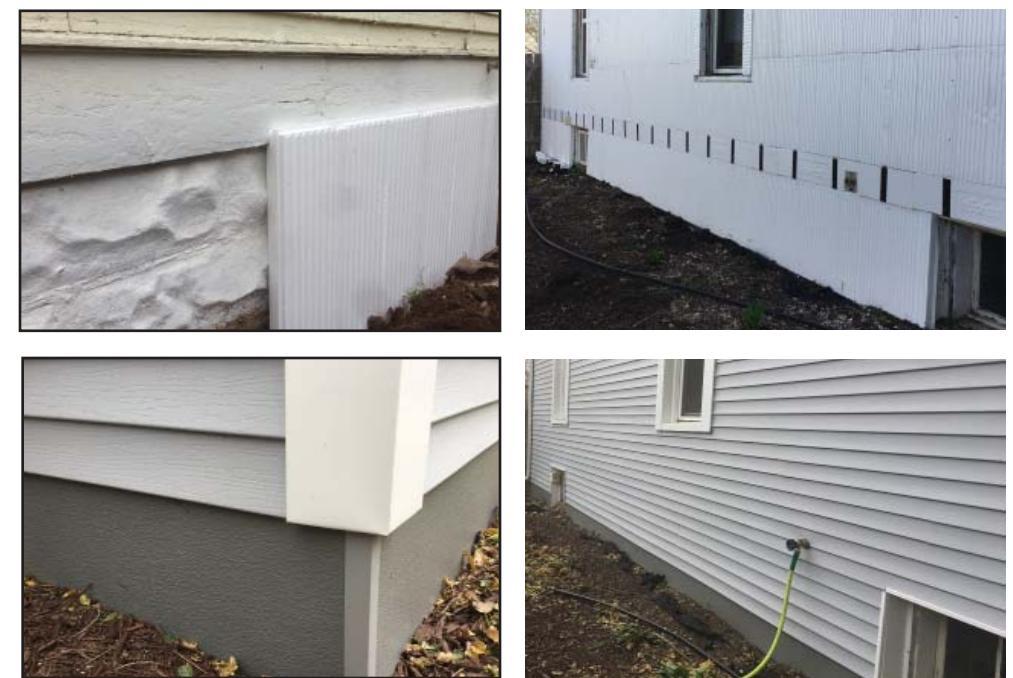
To address a high heat loss area, the top two feet of the foundation was insulated. The panels were adhered to the foundation wall with expanding spray foam and then screwed to the skirt board through the InSoFast studs.

The area between the dirt and the start of the siding was covered with a durable fiberglass foundation protection board.

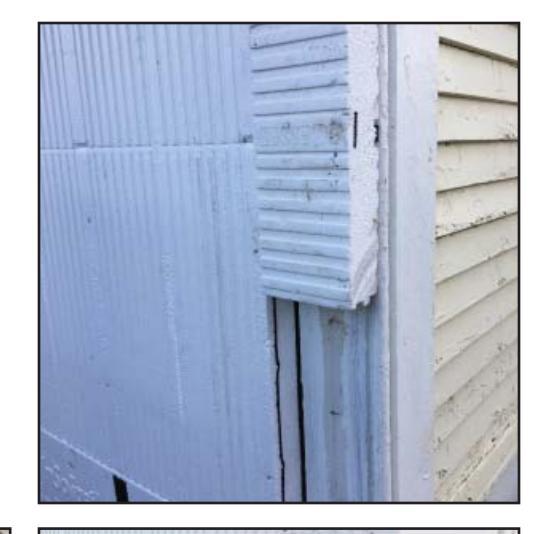
The existing skirt board, corner posts, and freeze board protruded 1/2" past the siding.

To account for that difference, the contractor used strips of the UX 2.0 panels (2" thick) to cover those areas.

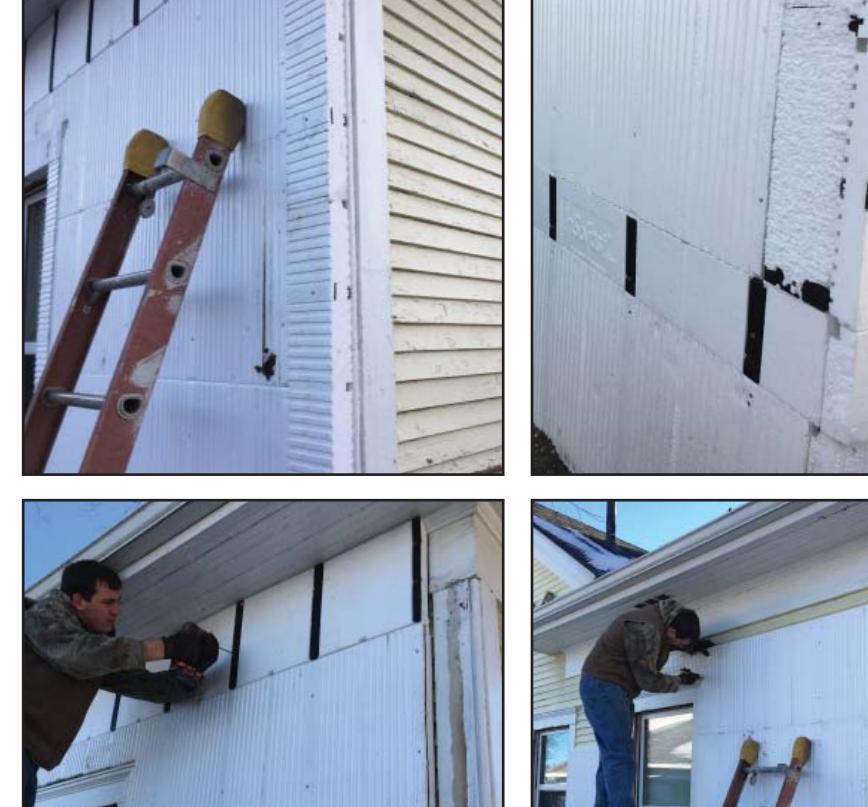
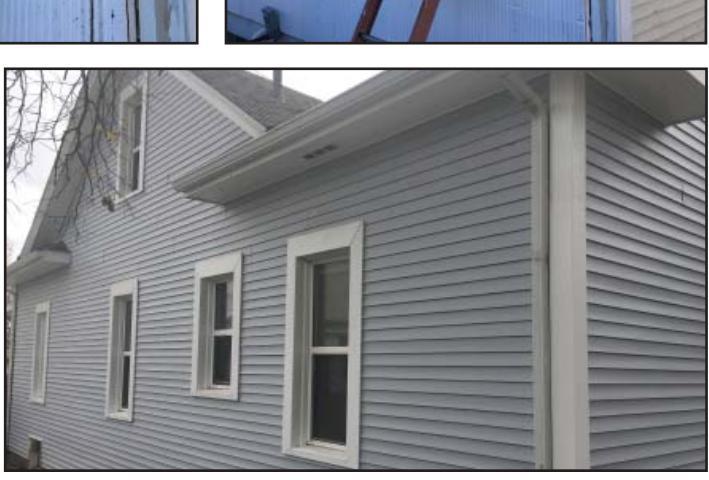
The EX 2.5 panels (2-1/2" thick) were then used to cover the siding. The result was a smooth, flat surface to start the new siding.

The freeze board is being covered by the UX 2.0 panel and the siding is covered the with EX 2.5 panels. It is important to line up the studs in both panels. The EX 2.5 has indicator lines to indicate where the studs are below the surface of the foam.

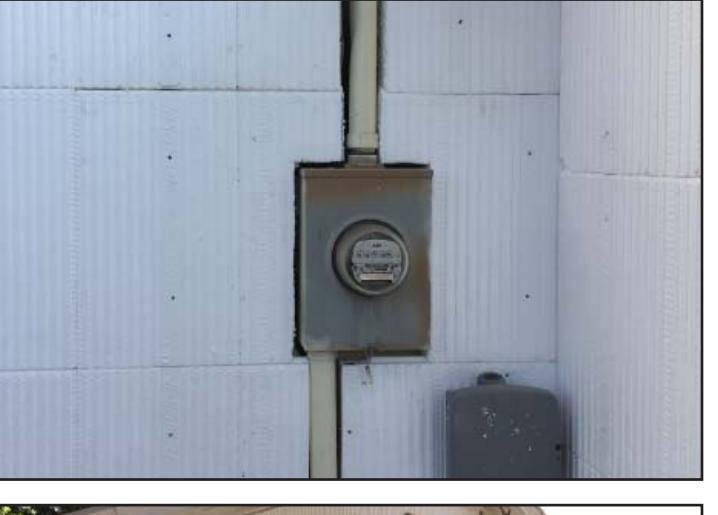
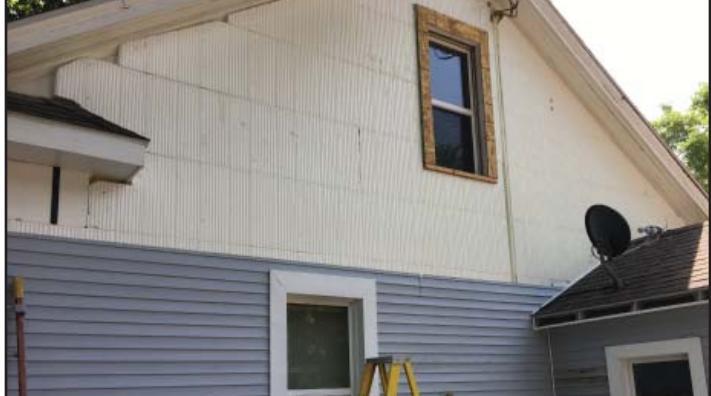
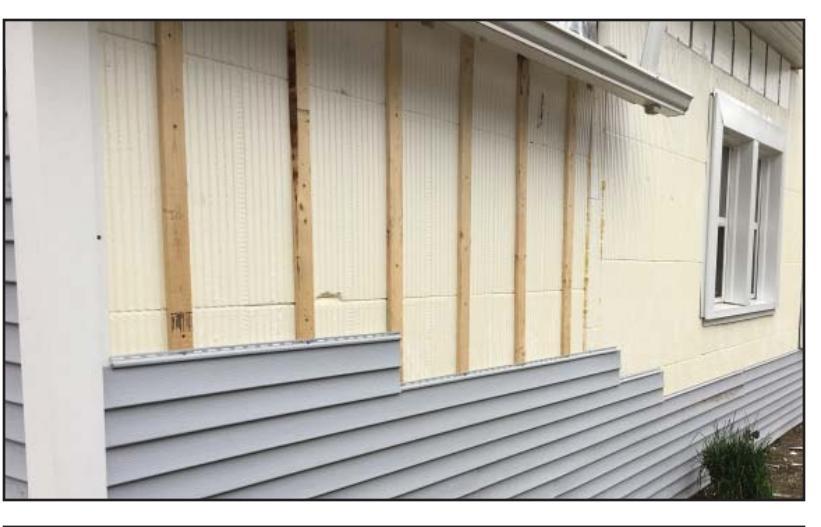
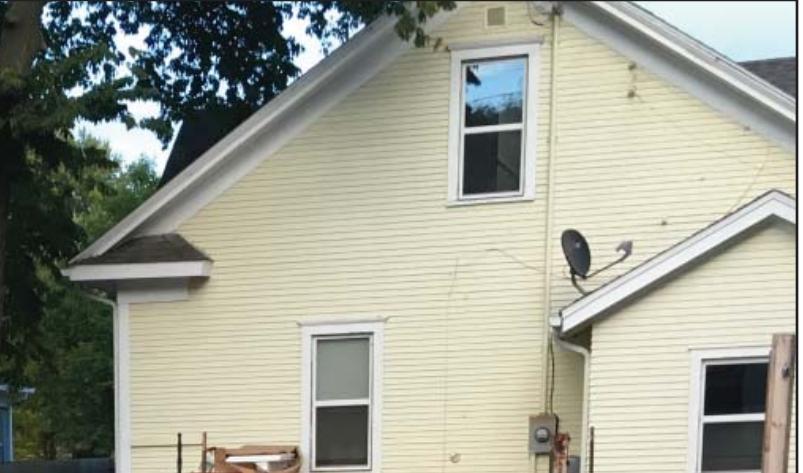
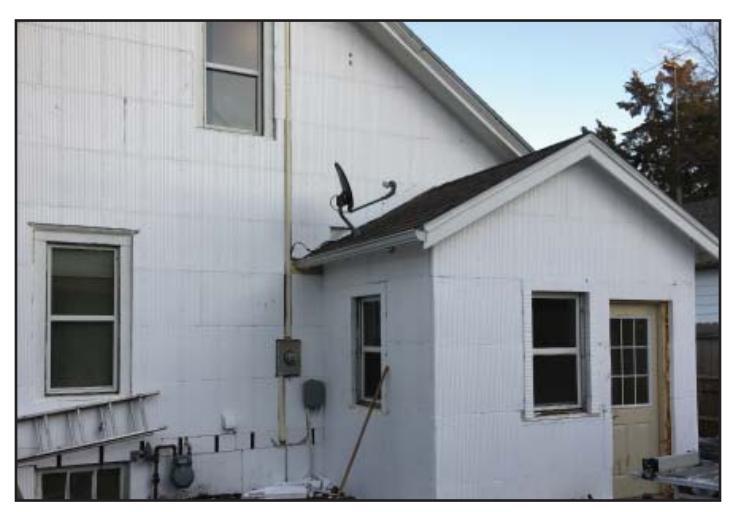
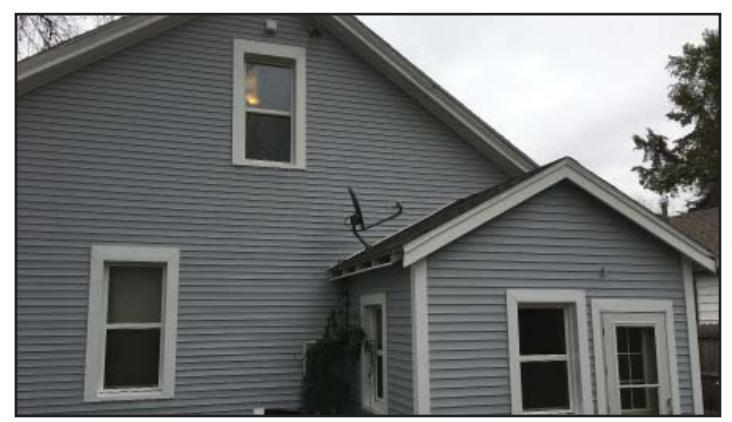
The old back porch addition had been set back 3/4" from the main house. Instead of jogging the siding, furring strips were screwed to the InSoFast embedded studs to flush out for the siding attachment.

Instead of boxing out for the electrical mast, the InSoFast panels were butted up to the metal conduit which flushed out the surface for siding. This greatly cleaned up the look of the back of the house.

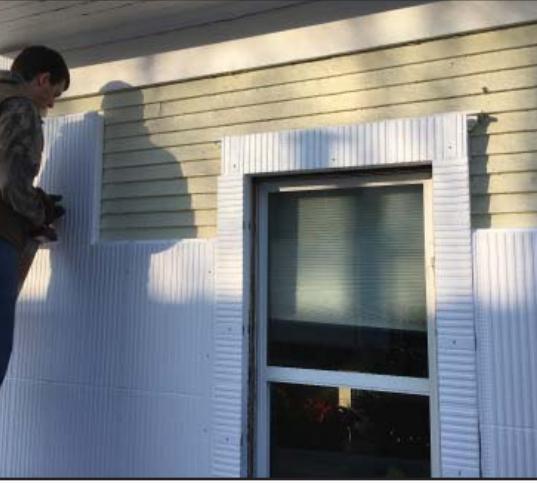
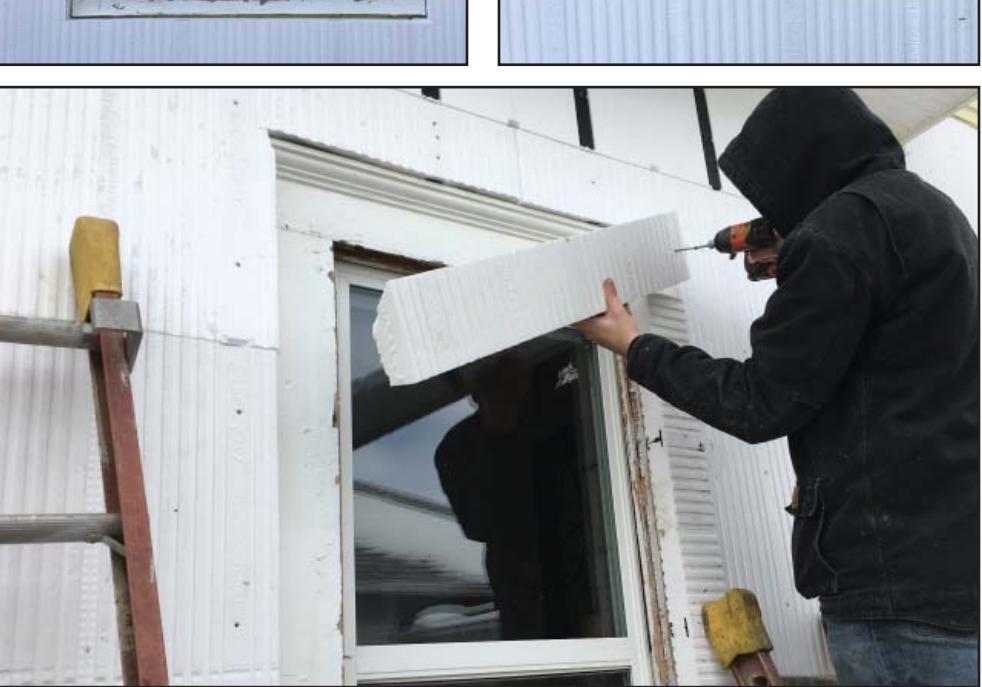
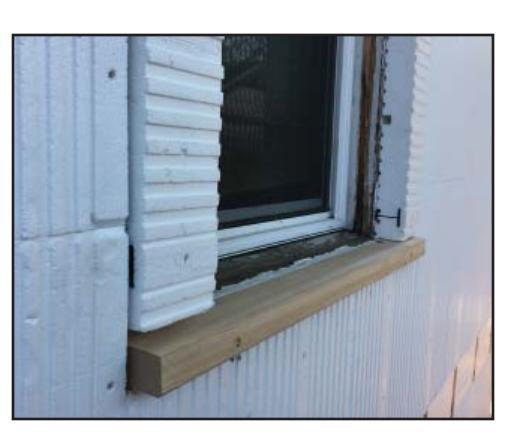
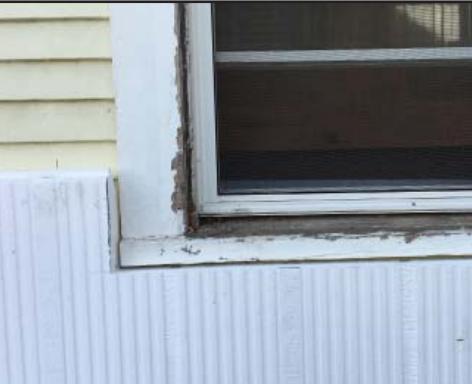
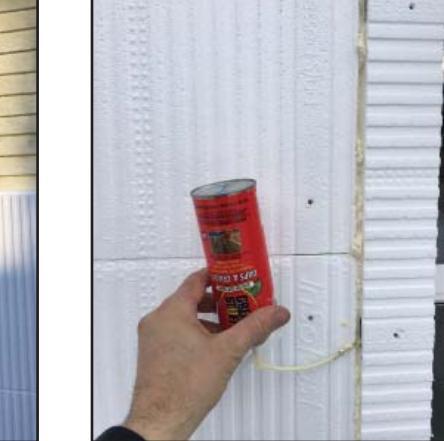
Replacement windows were installed. Window weights were removed and the weight pockets were insulated. None of the existing window trim was cut or removed. A solid sill extension was screwed to the existing window sill.

Scraps of EX 2.5 panels were cut into strips and installed directly over the existing trim.

The crown molding was left in place. Panels were trimmed on the back side of the foam to accommodate the crown molding.

Use spray foam to seal around all windows/openings before installing siding and trim.

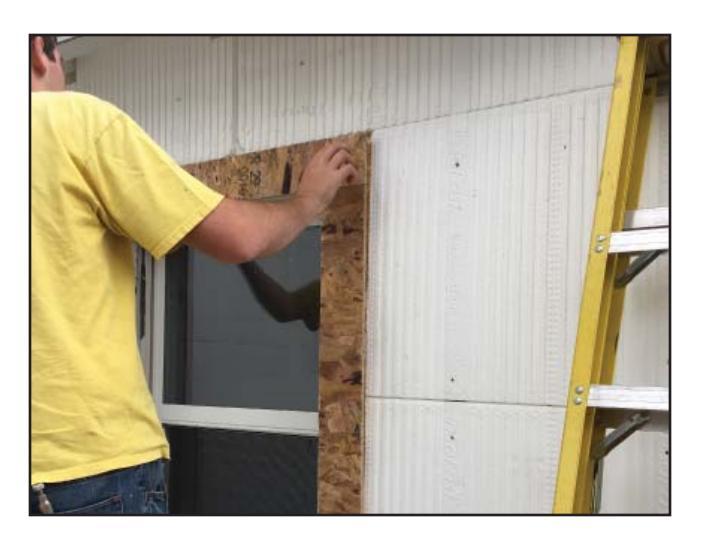
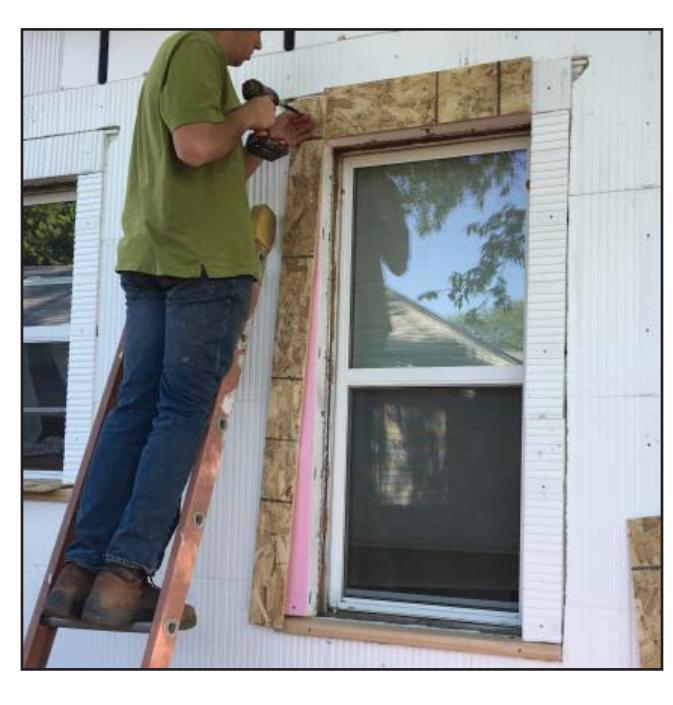
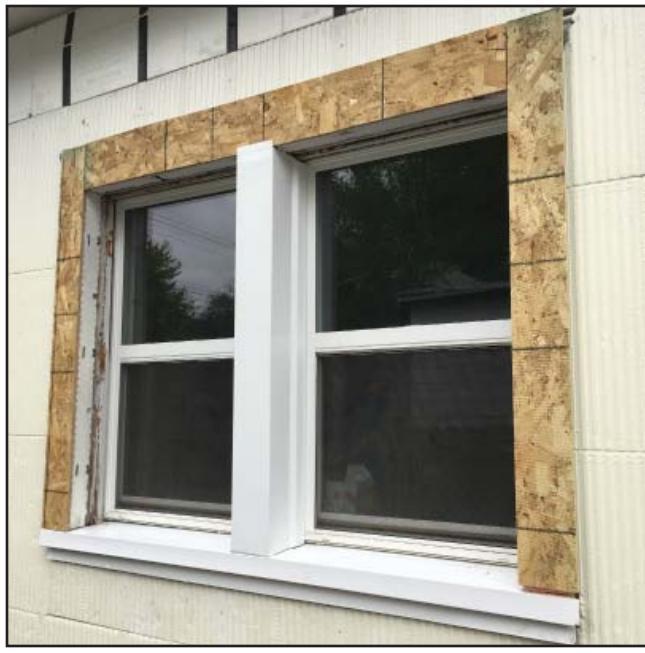
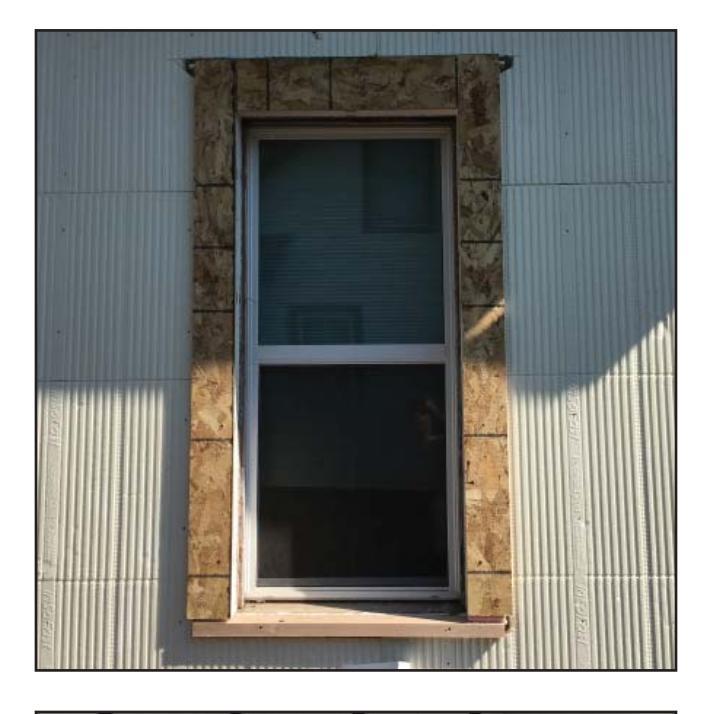
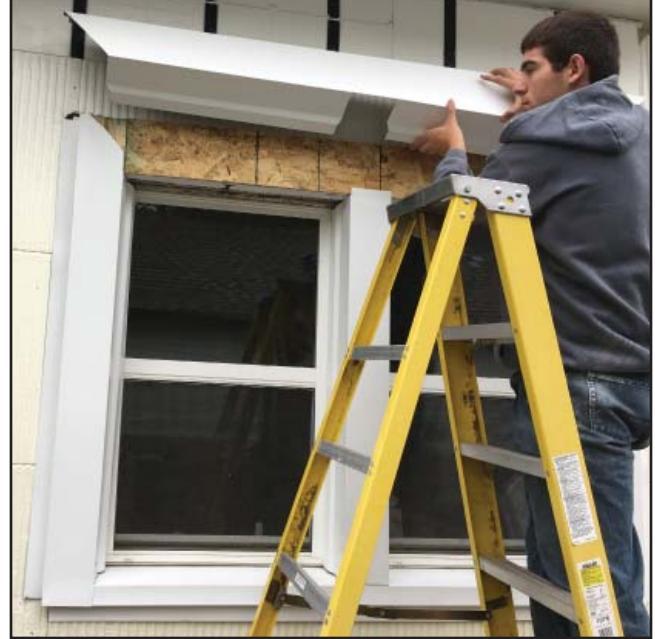
Plywood was used as a solid backer for the PVC covered coil stock. The plywood was extended 3/4" past the foam strips. This was done to incorporate the "J" channel into the window trim when the coil stock was bent up.

The windows could have been trimmed out with standard trim boards.
